NTCRAs Submunitions Area Controlled Burn/Remote Equipment Surface Clearance & Cayo La Chiva Underwater MEC Removal Vieques, PR

Naval Facilities Engineering Command (NAVFAC)

UXO 4 Submunitions Area TCRA Update

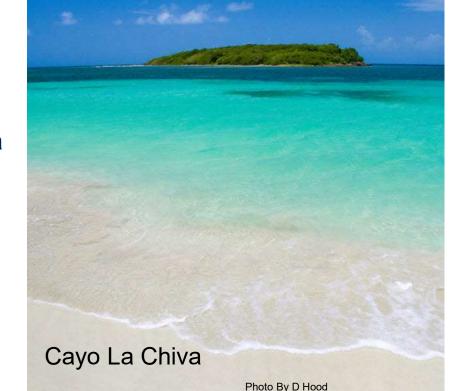
Signs at all public access points Signs on Cayo La Chiva Buoys around Cayo La Chiva

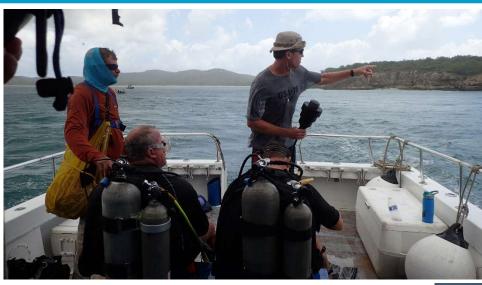
Dive Operations

Pre-Dive Operations: Safety Brief

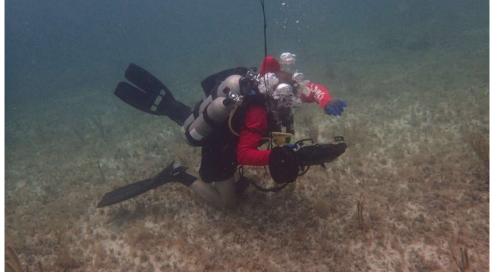
Target Location: Utilizing Underwater Navigation System

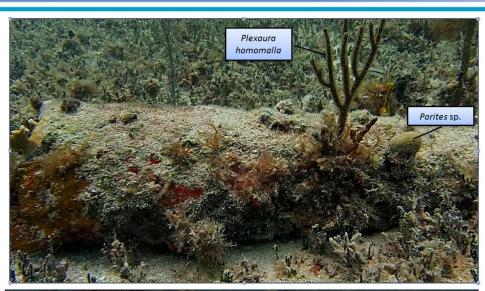
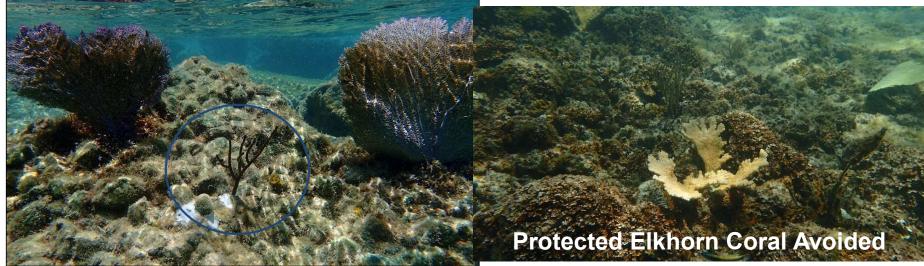
Biological Work

- Pre Removal Biological Survey:
 - Identify Protected Coral Species and Non Protected Corals that will be affected
- During the Removal:
 - Monitor Protected Species
 - o Relocate all Corals

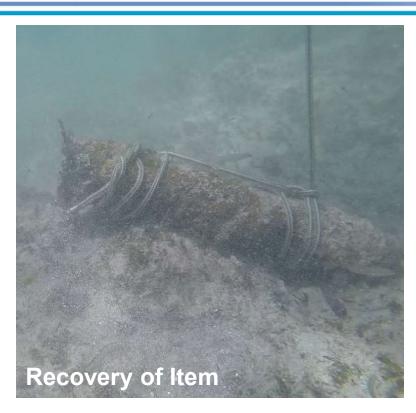
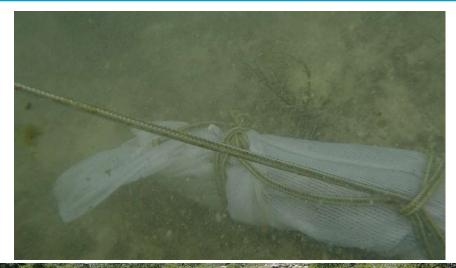
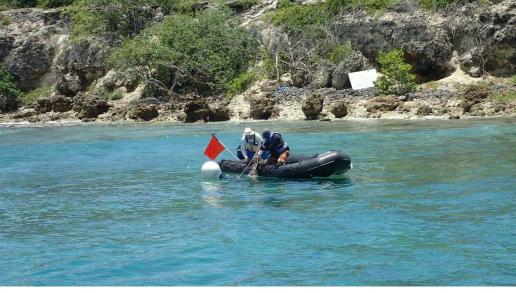
Recovery Operations

- Location 1 Cylindrical rock
- Location 2 5-inch rocket
 - Two ESA-listed corals found within 5 and 10 ft
- Location 3 5-inch rocket
 - Three ESA-listed corals found within 6, 10, and 15 ft
- Location 4 Cylindrical rock
- Location 5 Rock
- Location 6 MD fragment
- Location 7 5-inch rocket
- Location 8 5-inch rocket
- Location 9 5-inch rocket

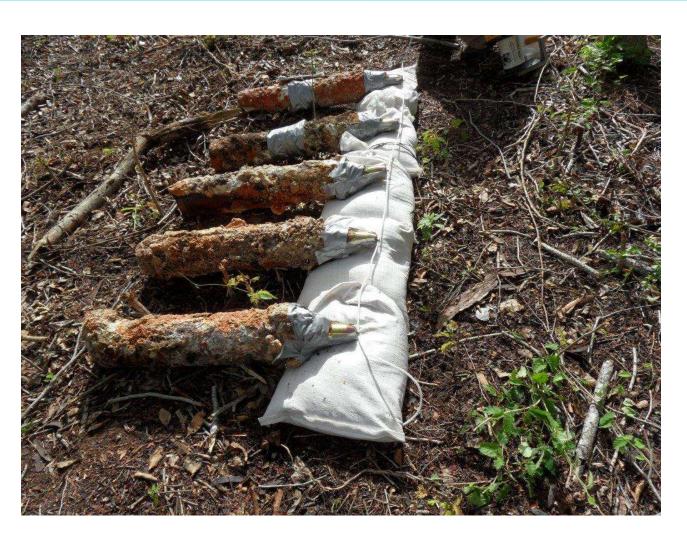
Demolition

- Items Appeared to be empty due to large visible rust holes.
- Attempted to perforate items to visibly inspect.

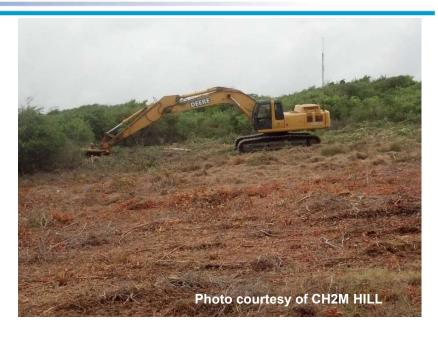
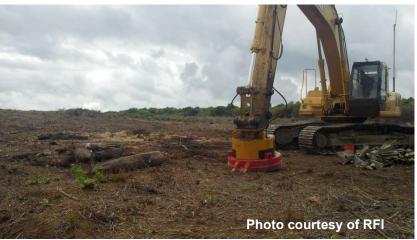
- Remote cutting of vegetation
 - Could not hand cut due to safety
 - Cutting required to burn

- Remote Removal of Bombs
 - Equipment capable of moving MEC (from 20 mm to 2,000 lb bombs)
 - Personnel located outside of fragmentation arcs
 - No manual handling of MEC or equipment for securing MEC
 - Large Item Demo conducted

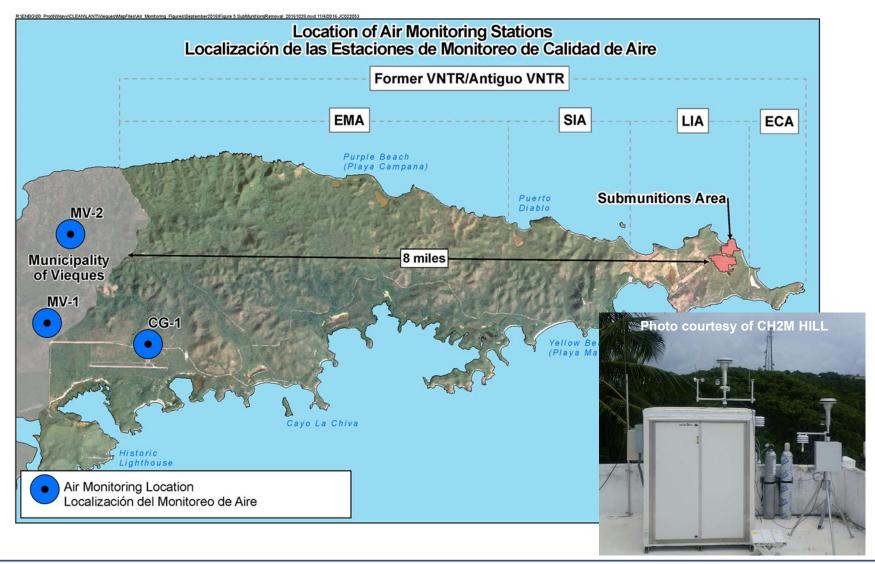
Air Monitoring Locations

Particulate matter

- PM₁₀ (particulate matter 10 microns or smaller in size)
- PM_{2.5} (particulate matter 2.5 microns or smaller in size)

Carbon monoxide

Explosives

НМХ	Nitrobenzene	1,3,5-Trinitrobenzene	2,6-Dinitrotoluene
RDX	1,3-Nitrobenzene	2,4-Dinitrotoluene	2,4,6-Trinitrotoluene

Metals

Arsenic	Copper	Iron	Mercury	Phosphorus
Cadmium	Chromium	Lead	Nickel	Tin

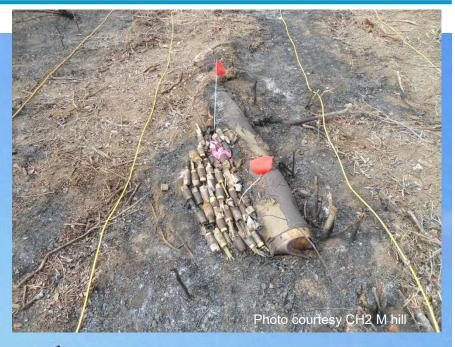
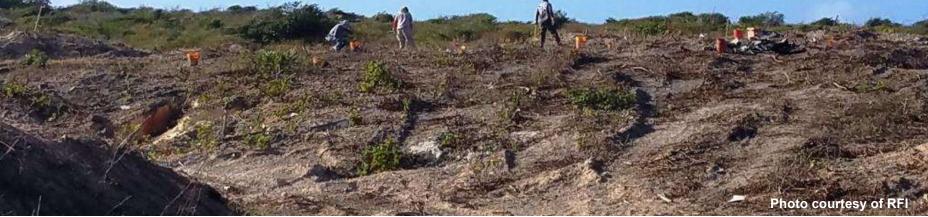
NTCRA Removal Process

- Step Five
 - MEC Surface Clearance
 - · QA
- Step Six
 - DEMO
- Step Seven
 - Final Surface
 - · QA
